Manhole Inspection Summary

Manhole # S39I__038MH

Insp Date: **8/20/08 9:42 AM**

Location Address: **side 750 e pratt st**

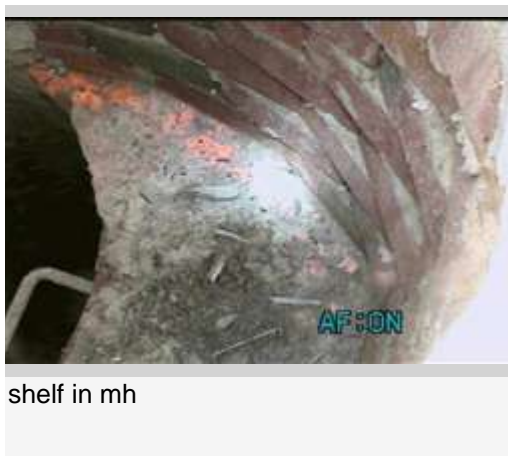
Miscellaneous

shelf in mh

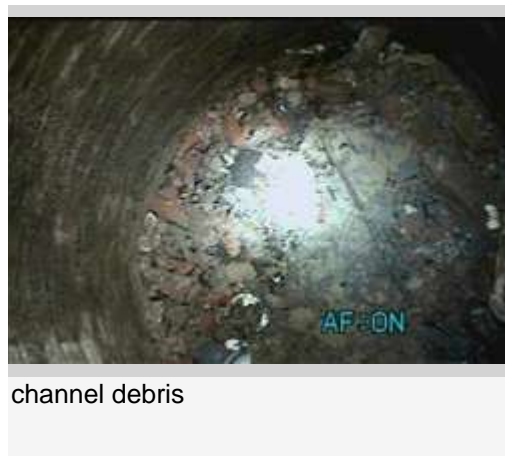
Defect 3

Condition: ☐ Sound ☐ Cracked ☐ Root Intrusion ☐ Deteriorated ☐ Leaks ☒ **Debris**

channel debris

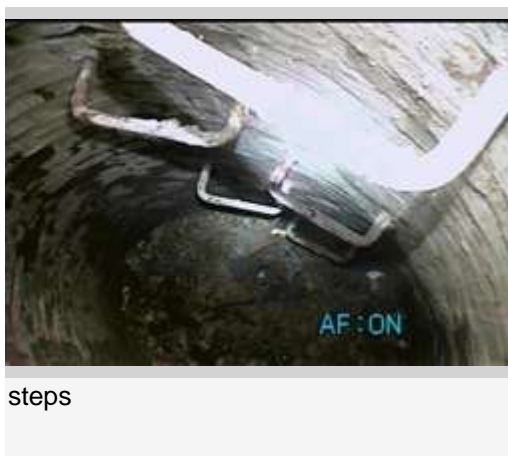
Defect 2

Steps Count: **5** Missing: **0** ☒ **Corroded**

steps

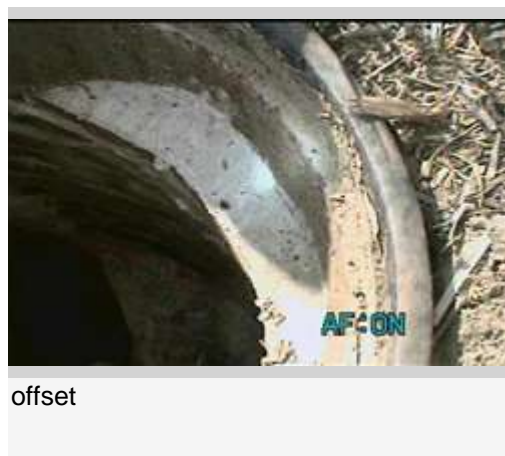
Defect 1

Frame Offset: **3** (in.) Condition: ☒ Sound ☐ Cracked ☐ Leaks

offset

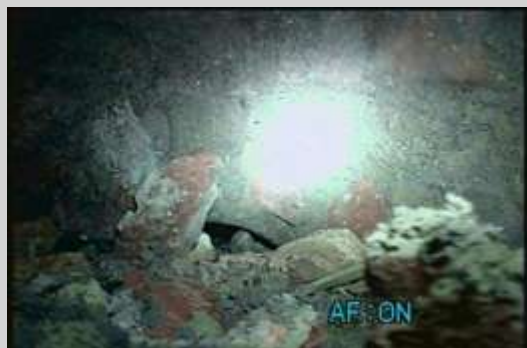
12 O'Clock Outflow

too much debris to see

Deposits: ☐ None ☐ Mud ☐ Sludge ☒ **Debris** ☐ Grease
